Debris/Ice/TPS Assessment And Integrated Photographic Analysis For Shuttle Mission STS-52

December 1992

DEBRIS/ICE/TPS ASSESSMENT
AND
PHOTOGRAPHIC ANALYSIS
OF
SHUTTLE MISSION STS-52

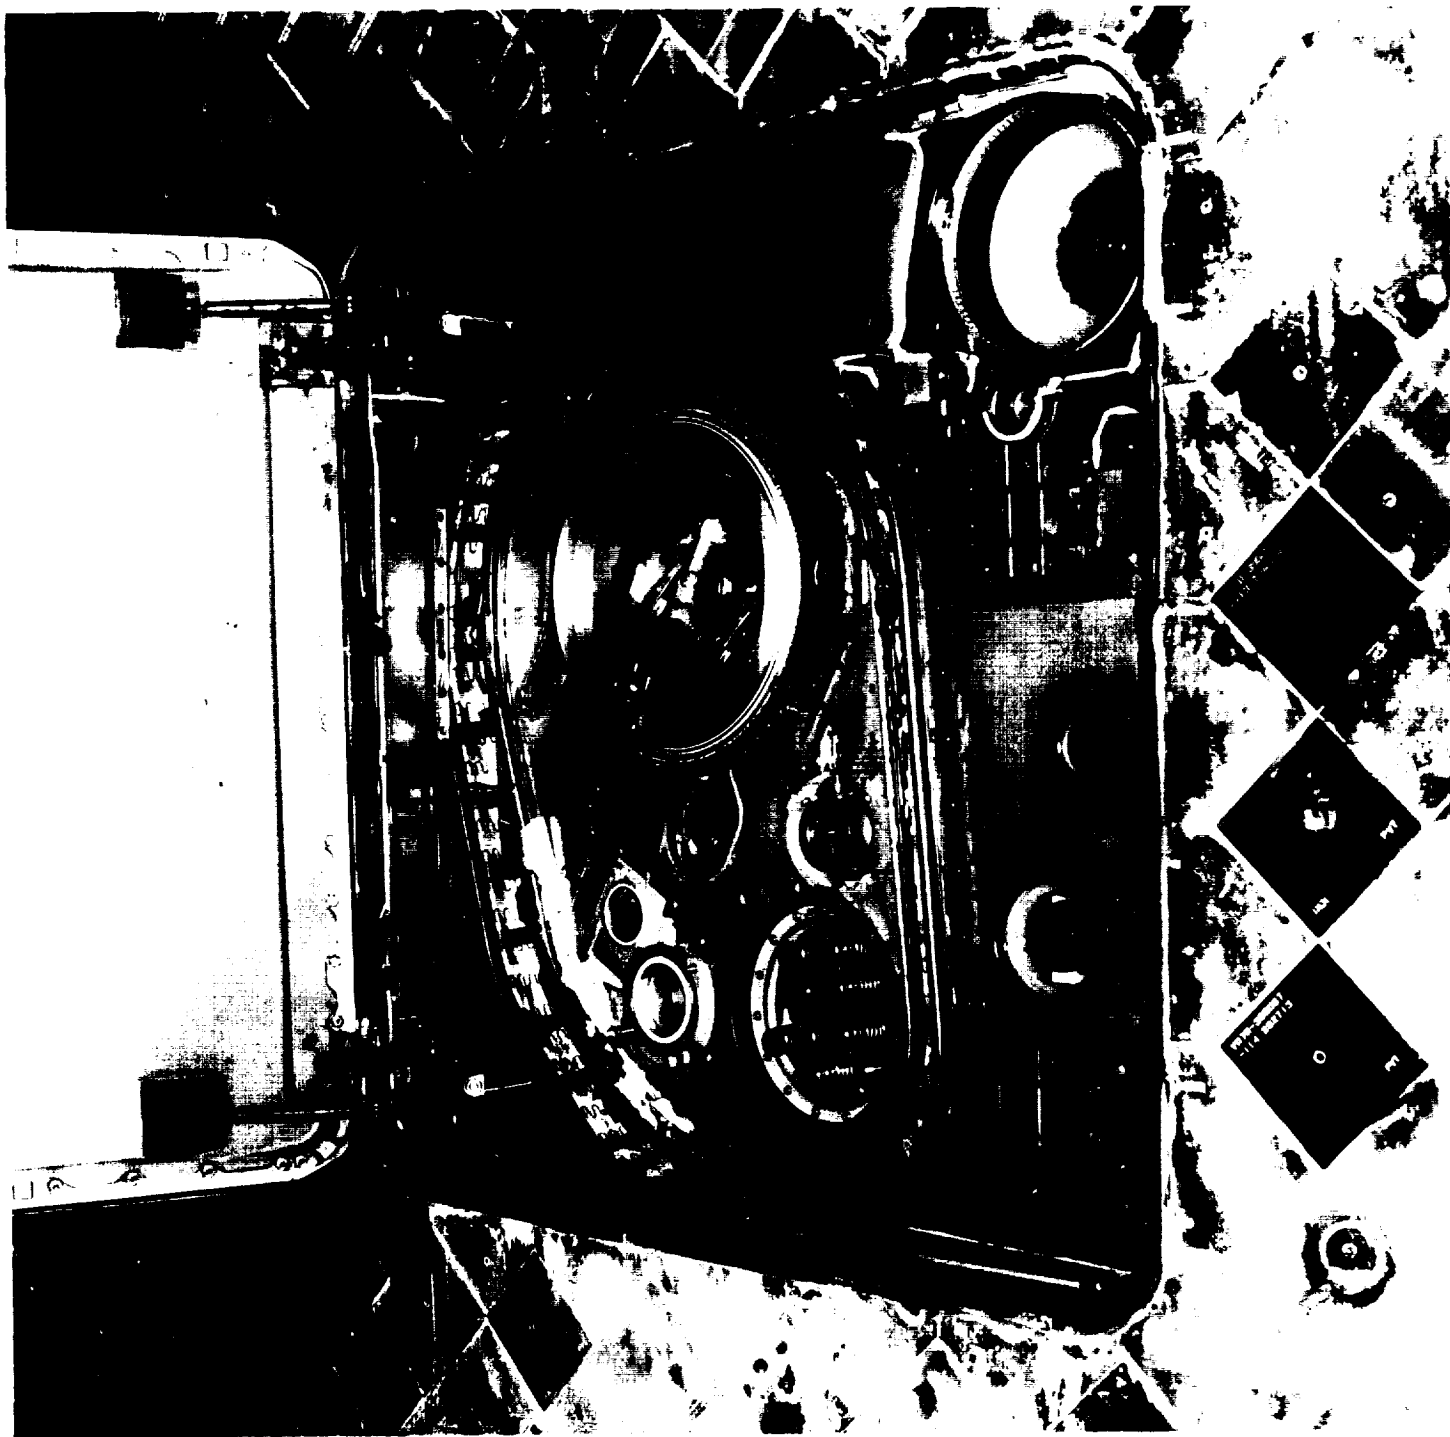
Overall view of the LH2 ET/ORB umbilical. All separation ordnance devices functioned properly. No flight hardware was found on the runway below the umbilical when the ET door was opened.

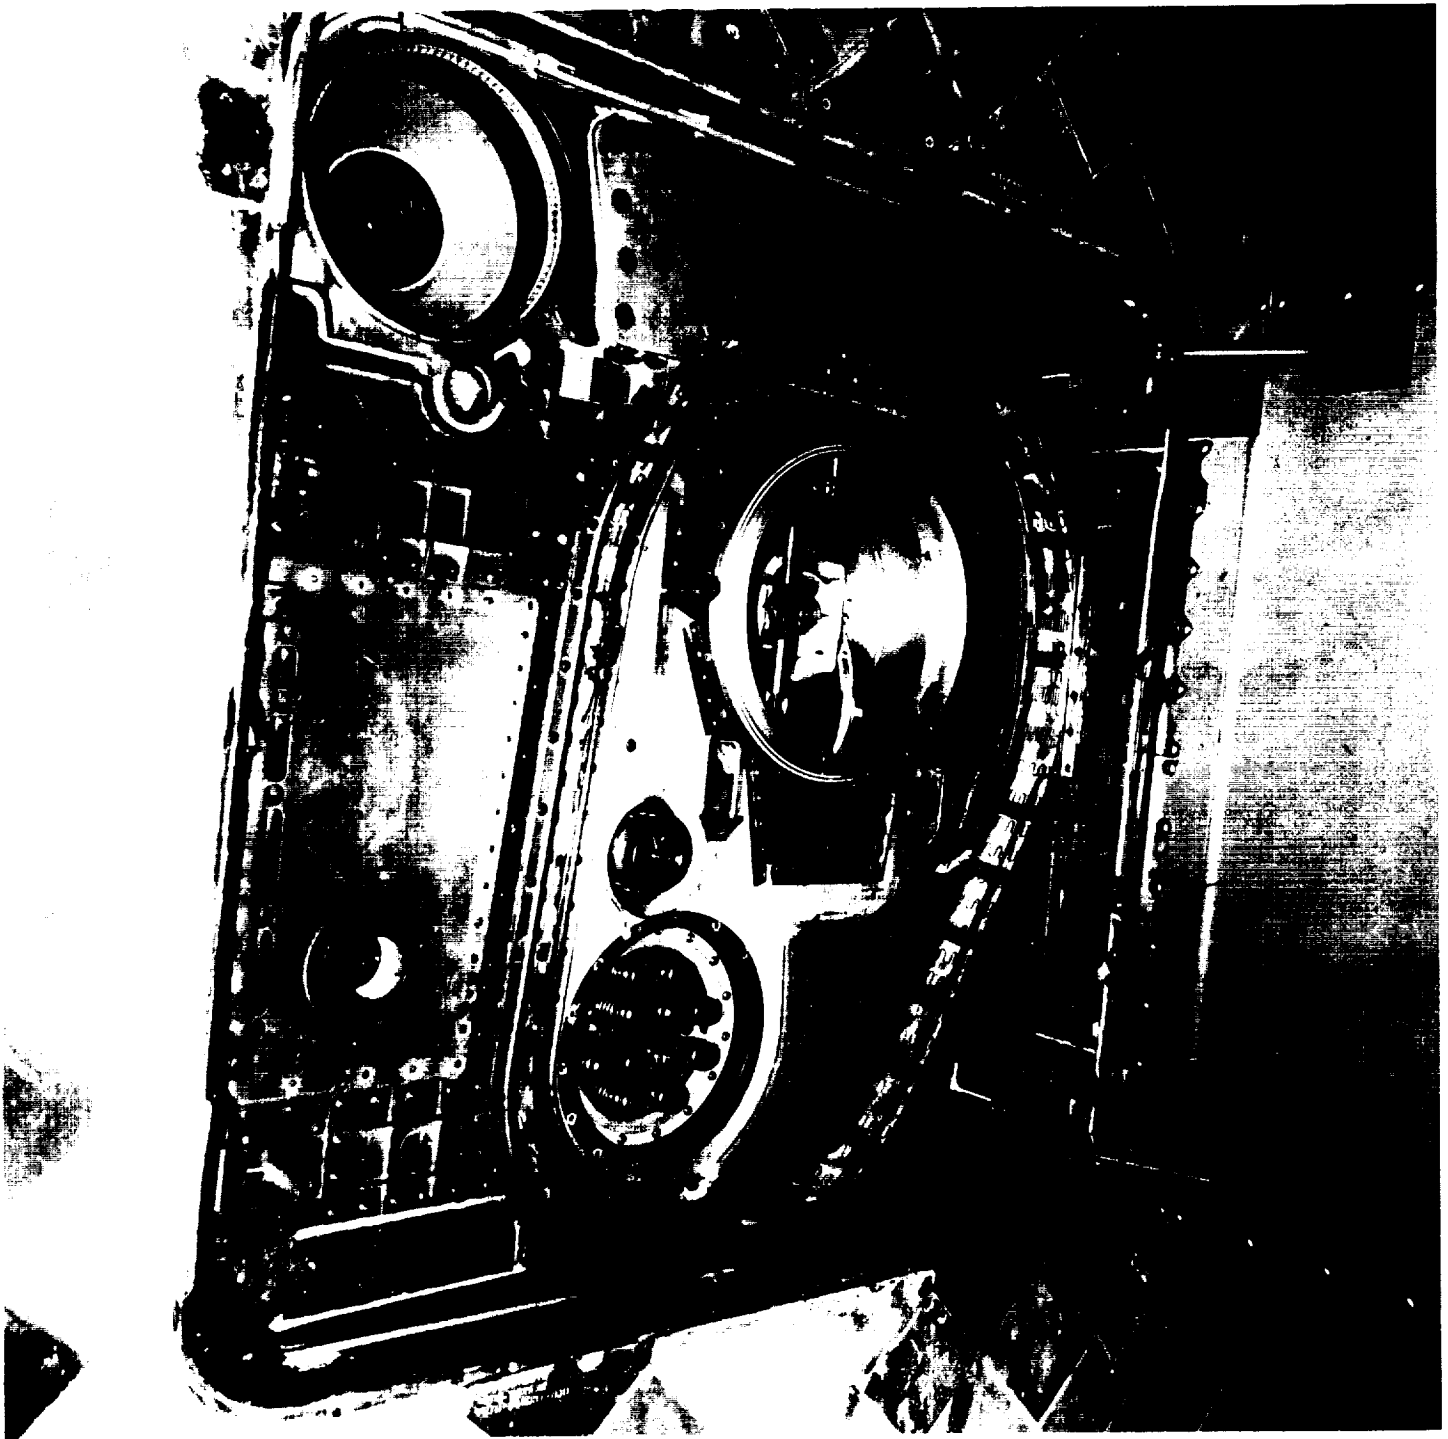
Overall view of the L02 ET/ORB umbilical. All separation ordnance devices functioned properly. No flight hardware was found on the runway below the umbilical when the ET door was opened.

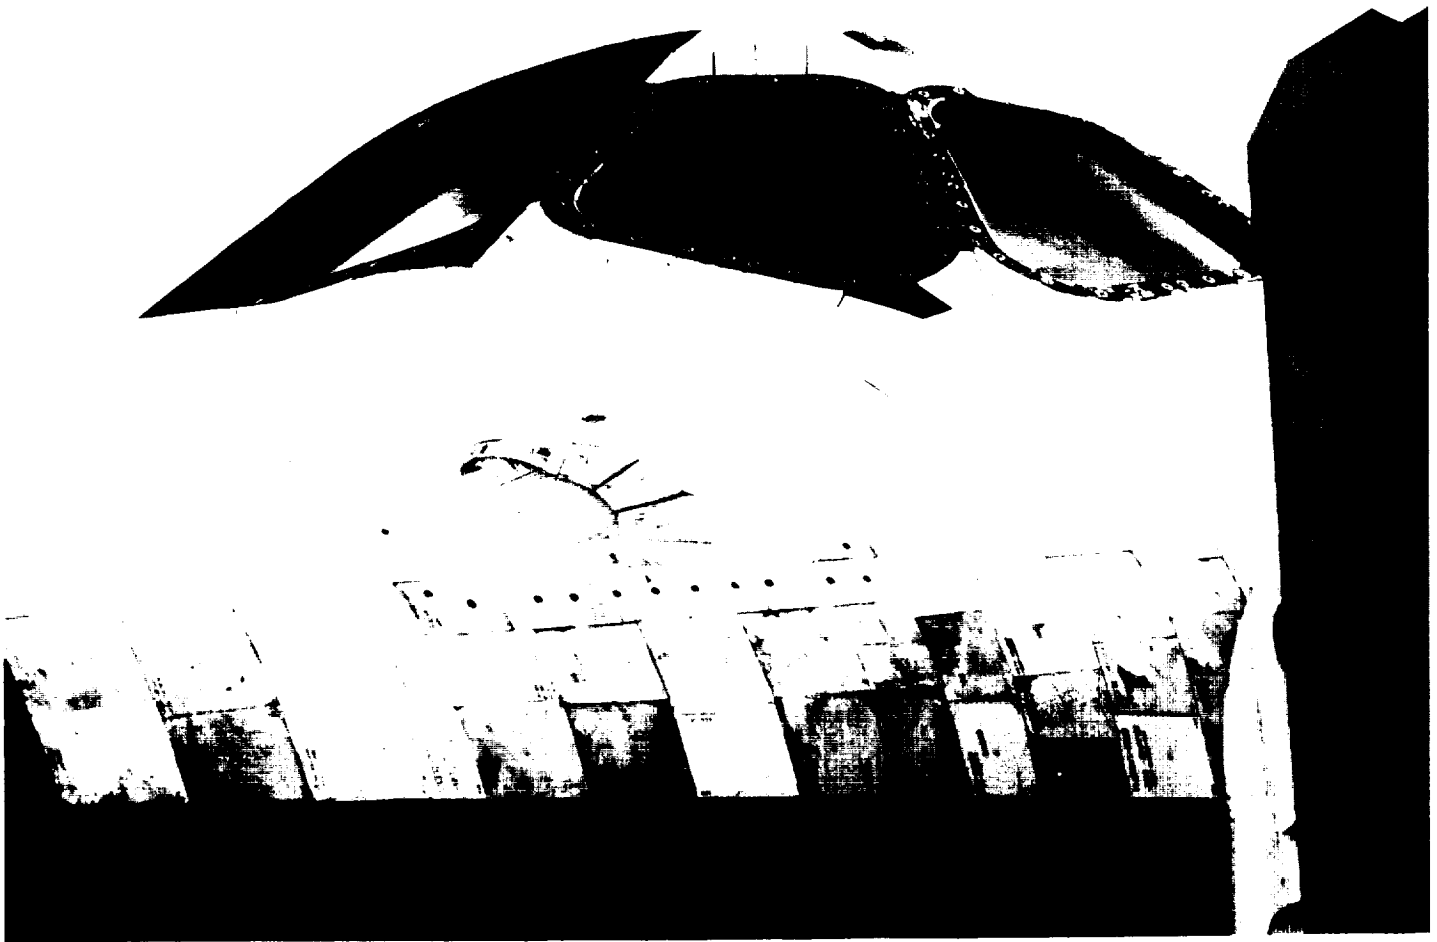
Hazing on the Orbiter windows was light and considered to be less than usual. A large number of tile impact sites (72 with 2 larger than 1-inch) occurred on the perimeter tiles around the forward facing windows. Most of the hits were small and shallow in depth.

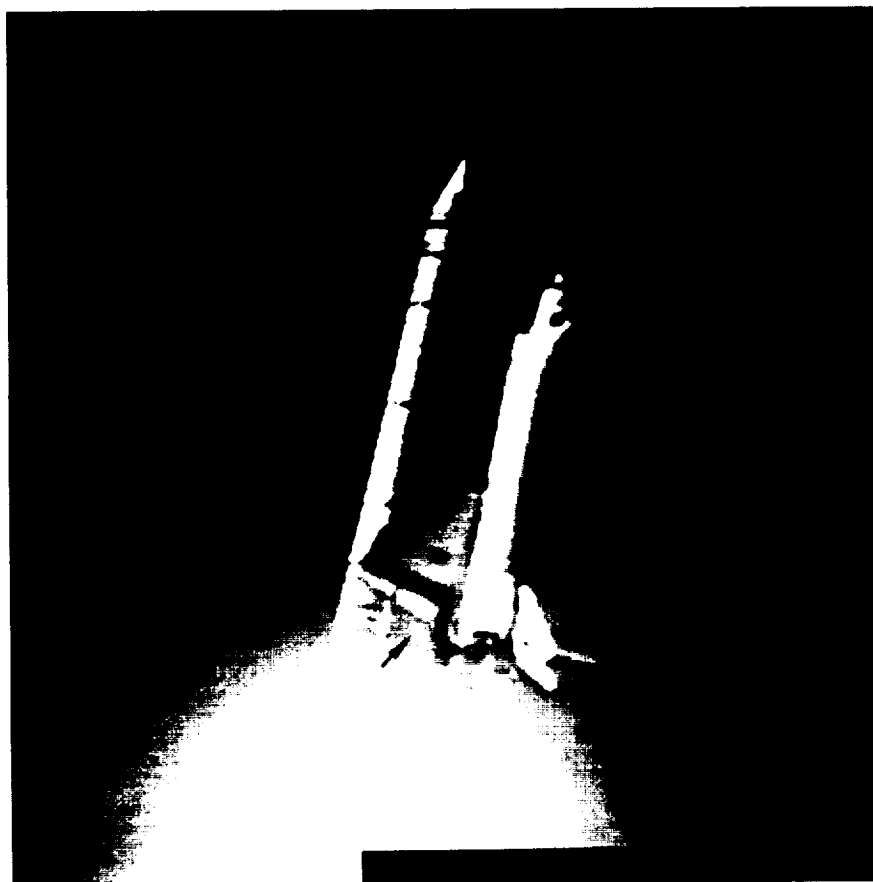
Figure 2.1.3.3 Large Piece of White Debris seen below Left Inboard Elevon after Roll Maneuver

A large piece of white debris was seen below the left inboard elevon traveling from left to right in the field-of-view at about 22 seconds MET. A source could not be determined from the available views. The object did not appear to strike the vehicle.

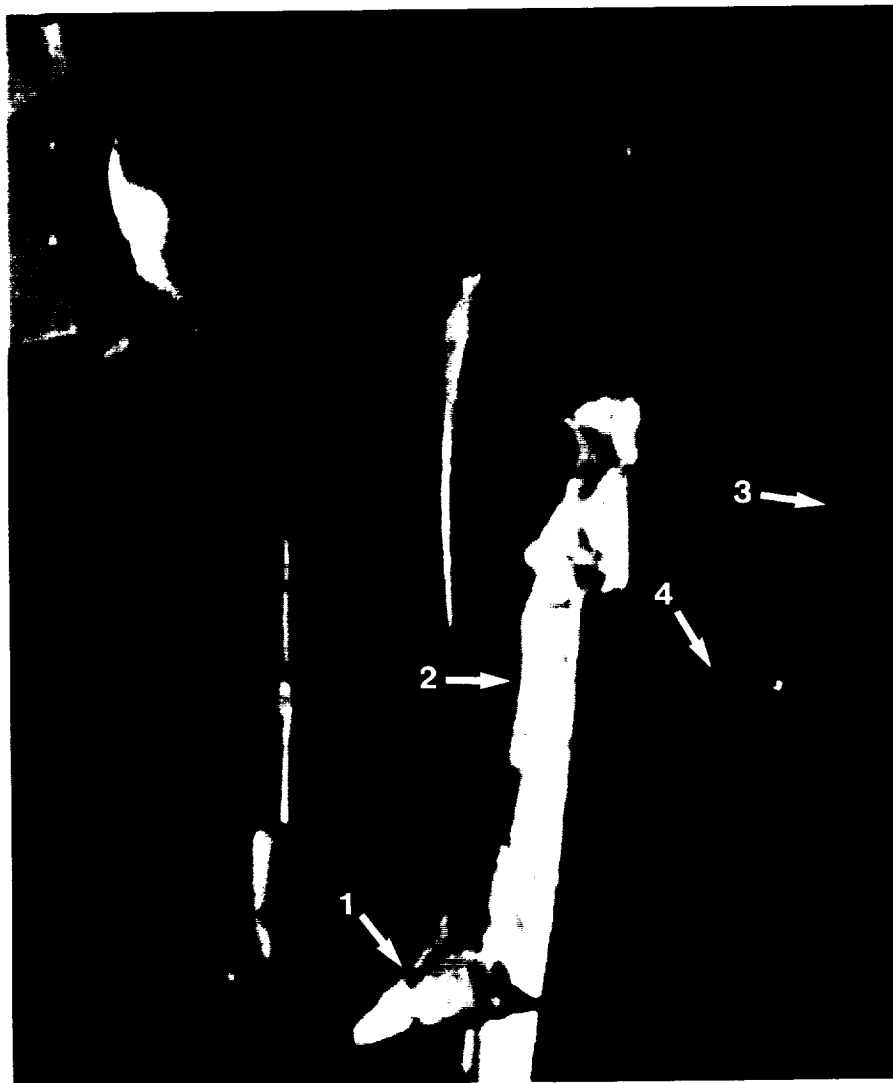
Figure 2.4.1.2 (B) LH2 ET Umbilical at ET Separation

A small piece of foam like material moved across the ET LH2 umbilical just after ET separation (1). A blistered appearance to the TPS on the left side of the LH2 umbilical was visible as the ET began to move away from the Orbiter (2). Ice was visible in the orifice of the LH2 17 inch line as the LH2 umbilical came into full view (3). The bushing sleeves appeared to be present in their proper positions (4). (The cylindrical-shaped debris object seen on the STS-40 umbilical well film was believed to have been a dislodged bushing sleeve).
